RE: Powder Springs Road Plating
Austell, Cobb County, Georgia
Preliminary Assessment Report

**PRELIMINARY ASSESSMENT
POWDER SPRINGS ROAD PLATING
AUSTELL, COBB COUNTY, GEORGIA**

June 2019

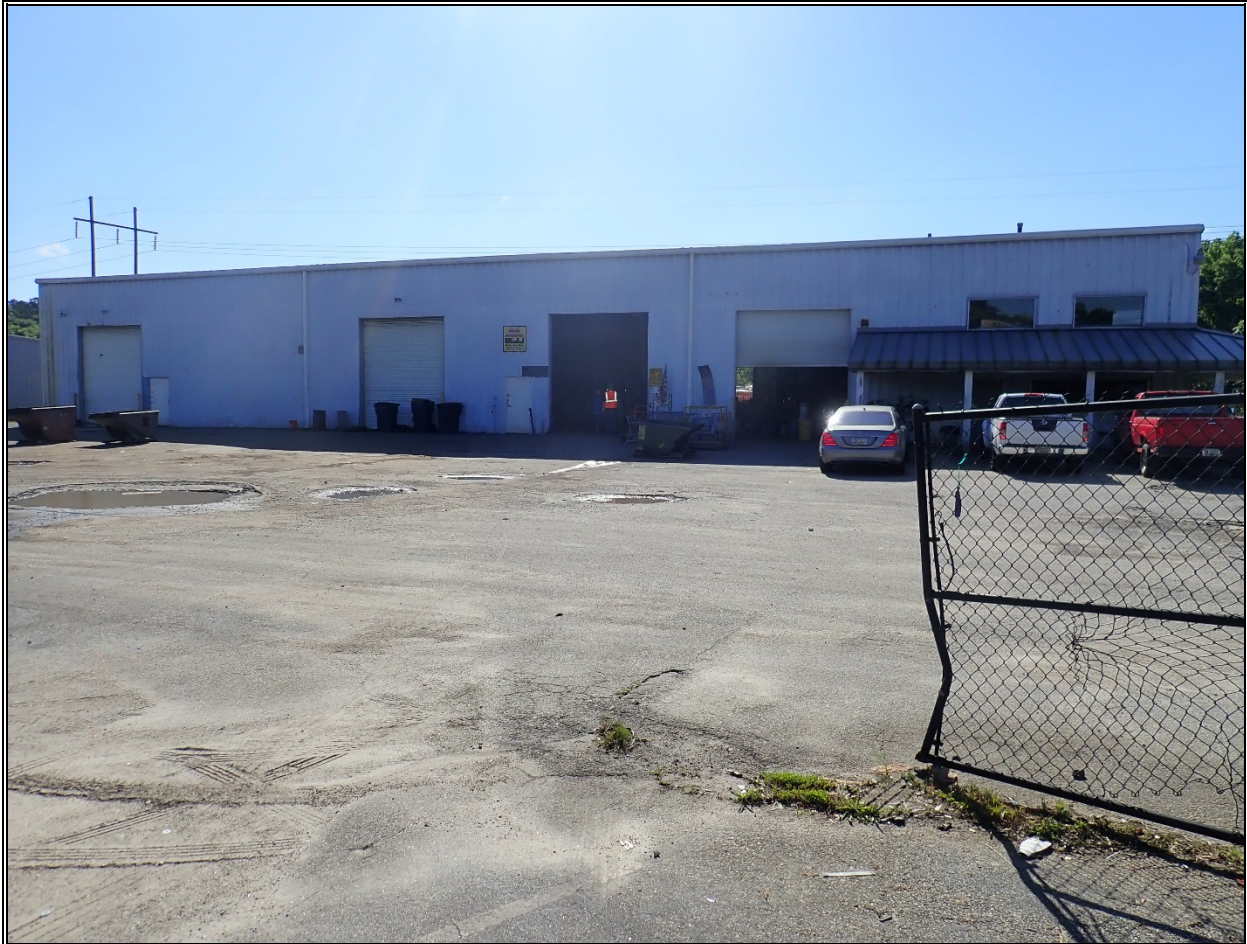
One approximately 9,000 square foot metal building (hereinafter referred to as “Building A”) was observed approximately 75 east of Austell Powder Springs Road.

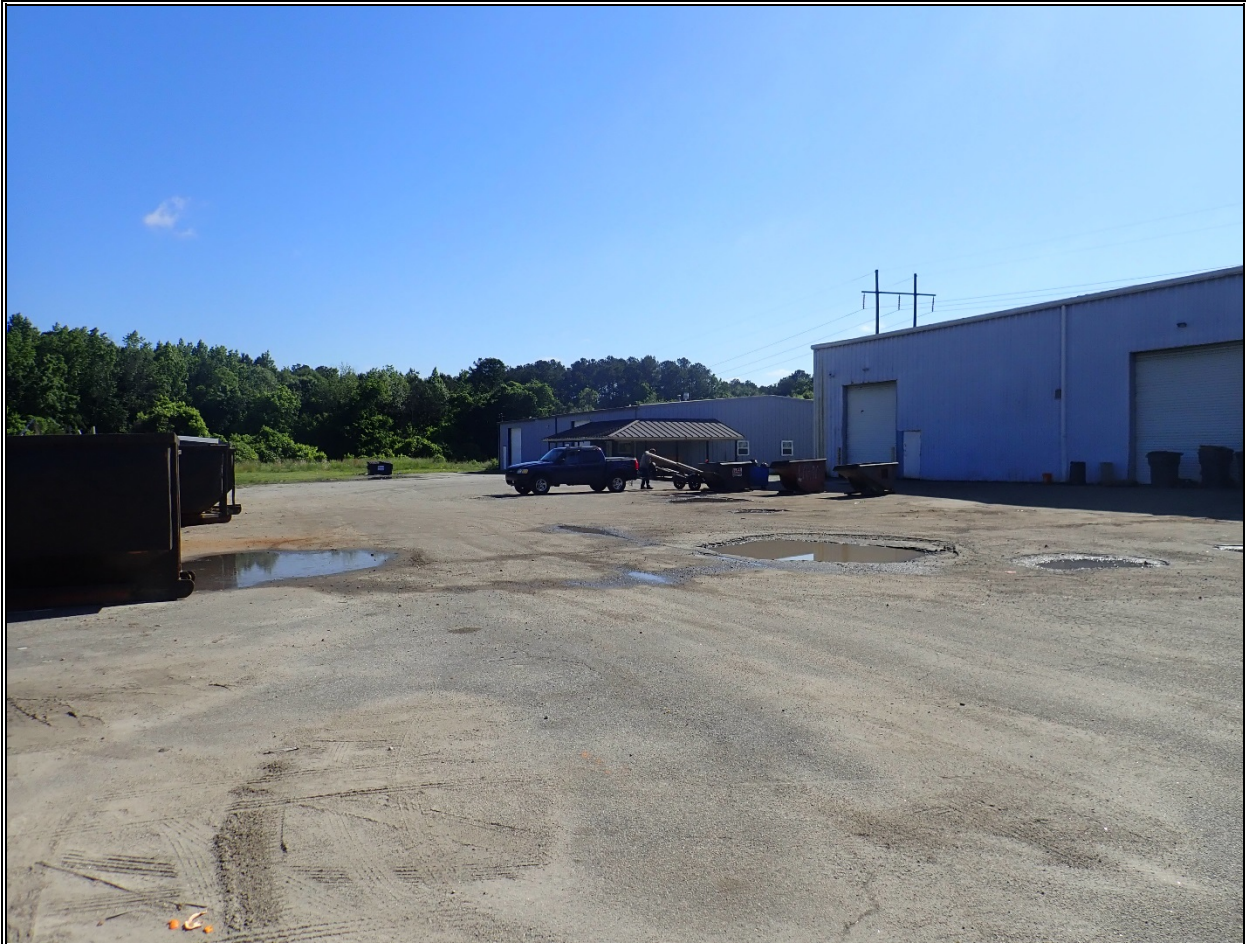
Building A (right side of photograph) and a smaller, approximately 600 square foot metal building (hereinafter referred to as “Building B”) was observed approximately 40 feet northeast of Building A. A small truck and trailer are shown near the central portion of the photograph near the smaller roll-off boxes carrying a load for metal recycling drop-off. The larger roll-off boxes used for holding larger metals are located on the left side of the photograph.

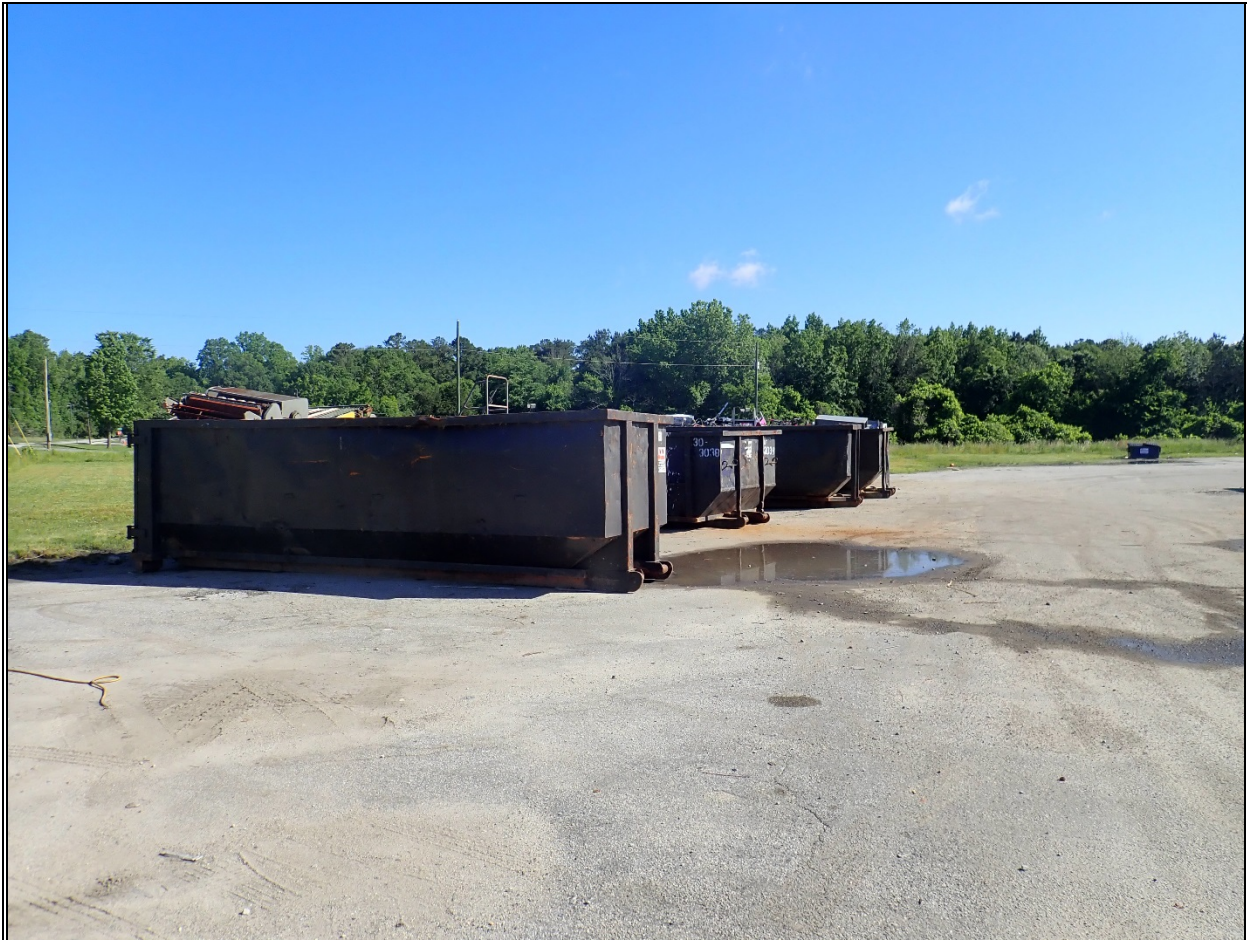
Roll-off boxes used to hold larger pieces of scrap metal positioned along the northern edge of the paved on-site parking area, approximately 100 feet northwest of Building A.

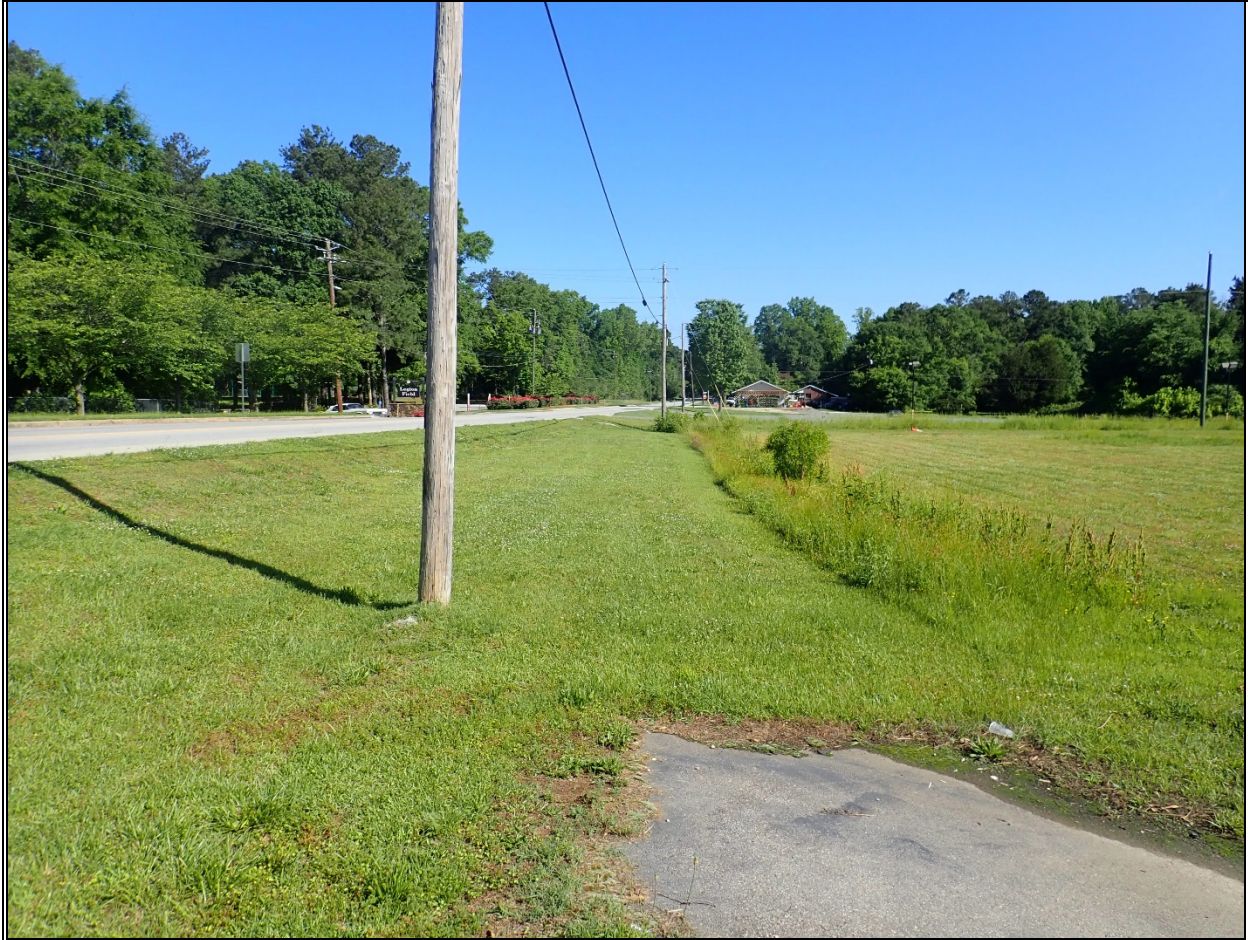
The USEPA 2009/2010 Removal Action was conducted in the approximate area of the freshly mowed area near the central portion of the photograph, just east of the ditch and north of the roll-off boxes.

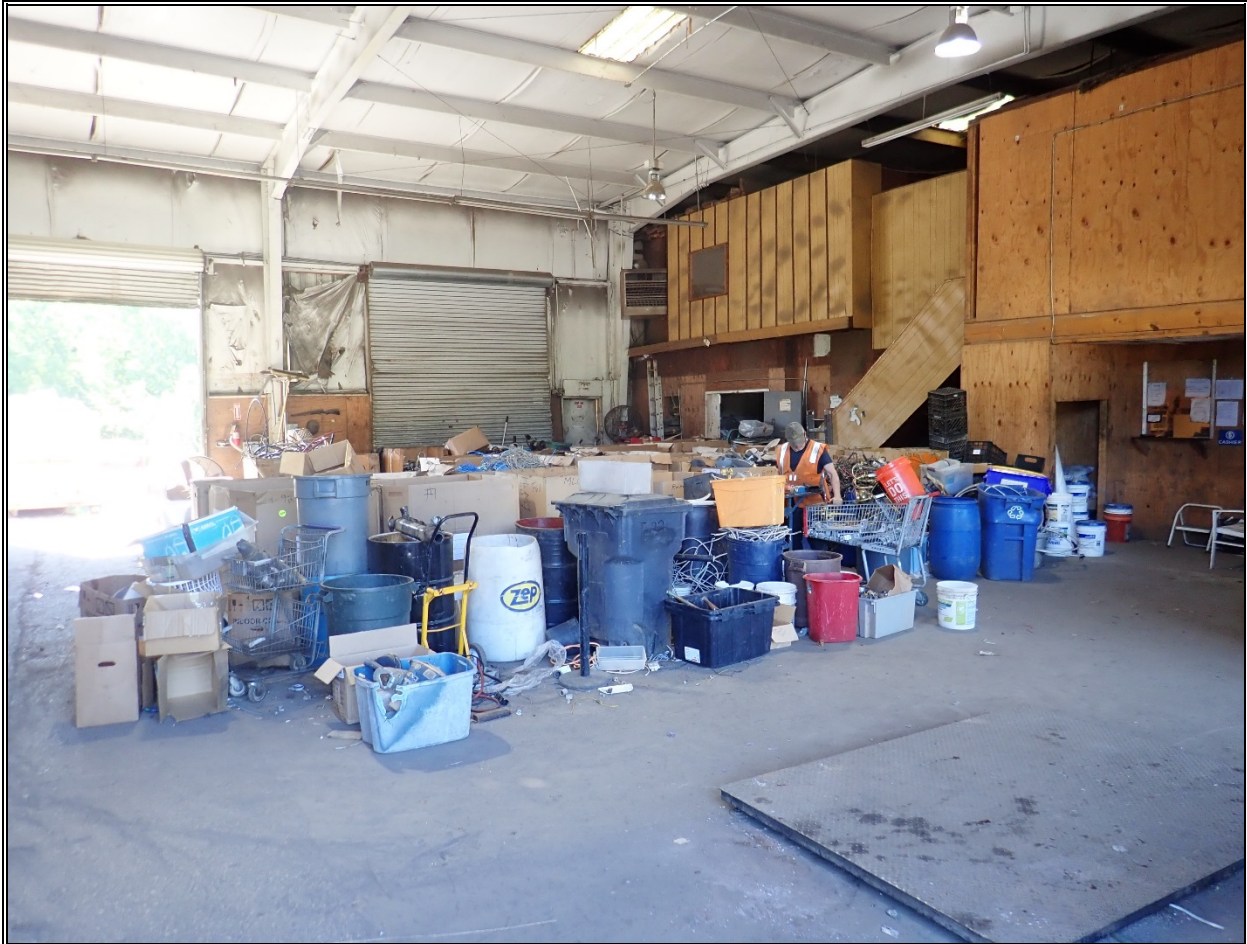
Various metals organized in multiple containers within the western portion of the interior of Building A.

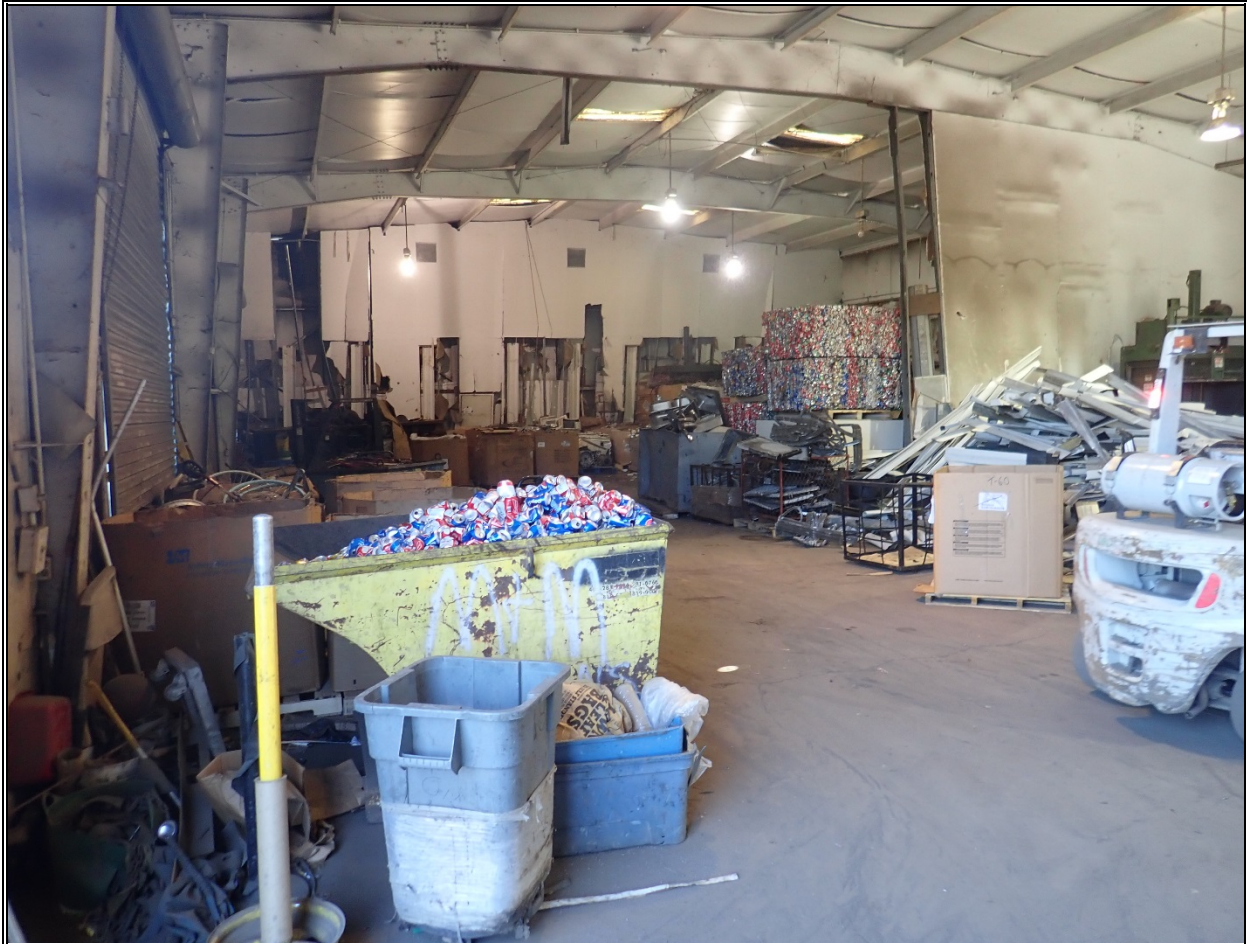
Various metals, including aluminum cans within the central and eastern portion of the interior Building A.

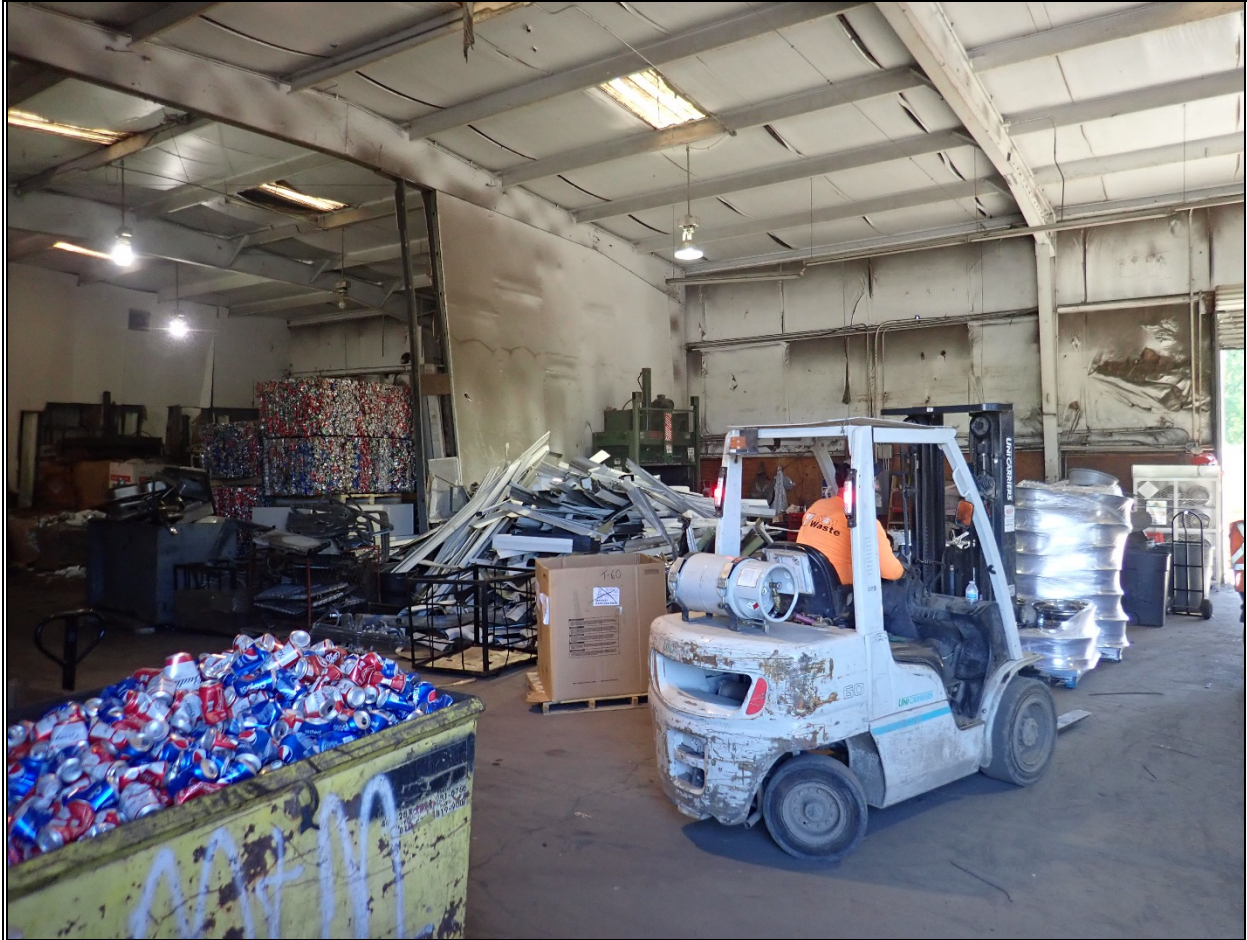
Various metals, including aluminum cans and scrap metal within the central and eastern portion of the interior of Building A.

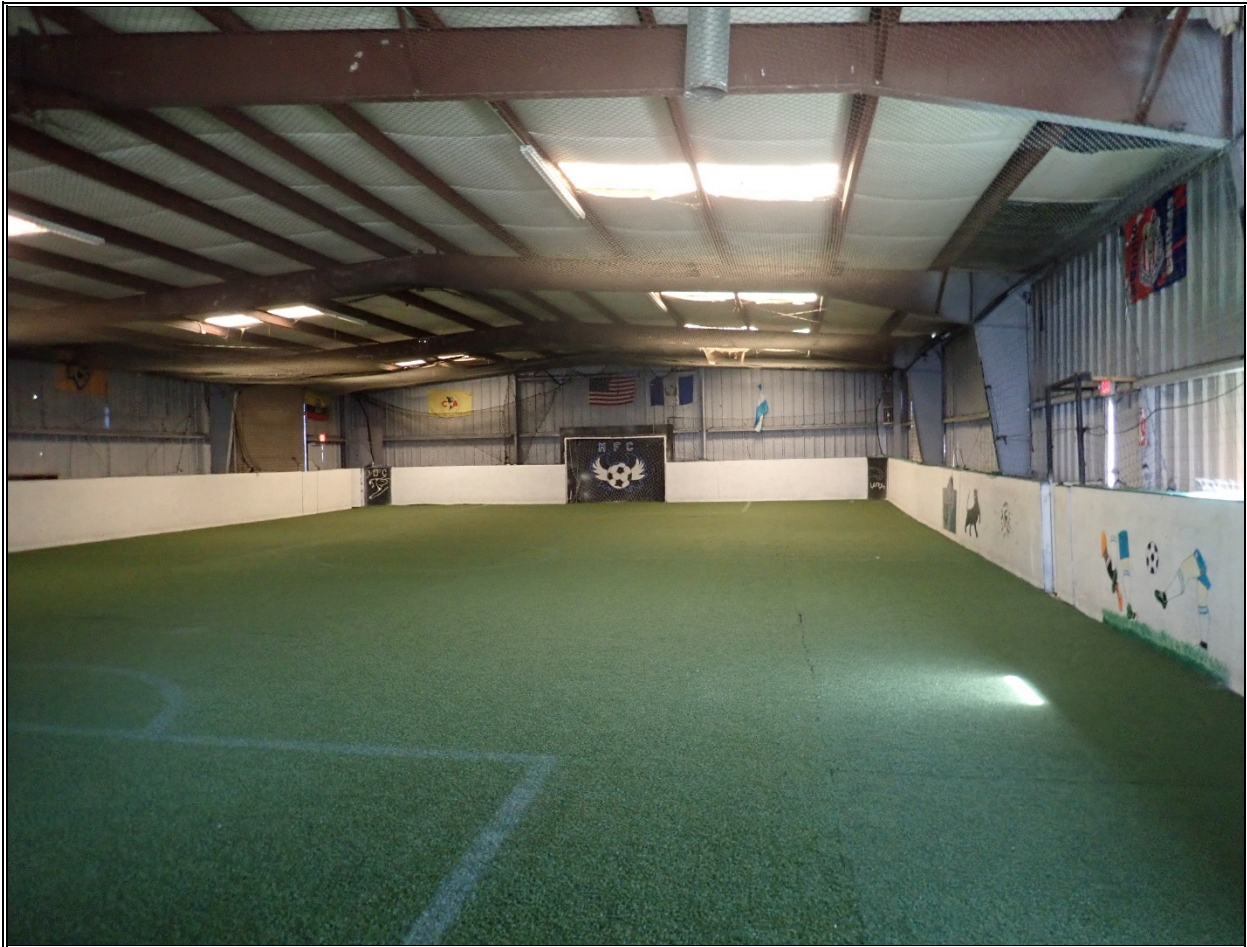
An indoor soccer field located within Building B.

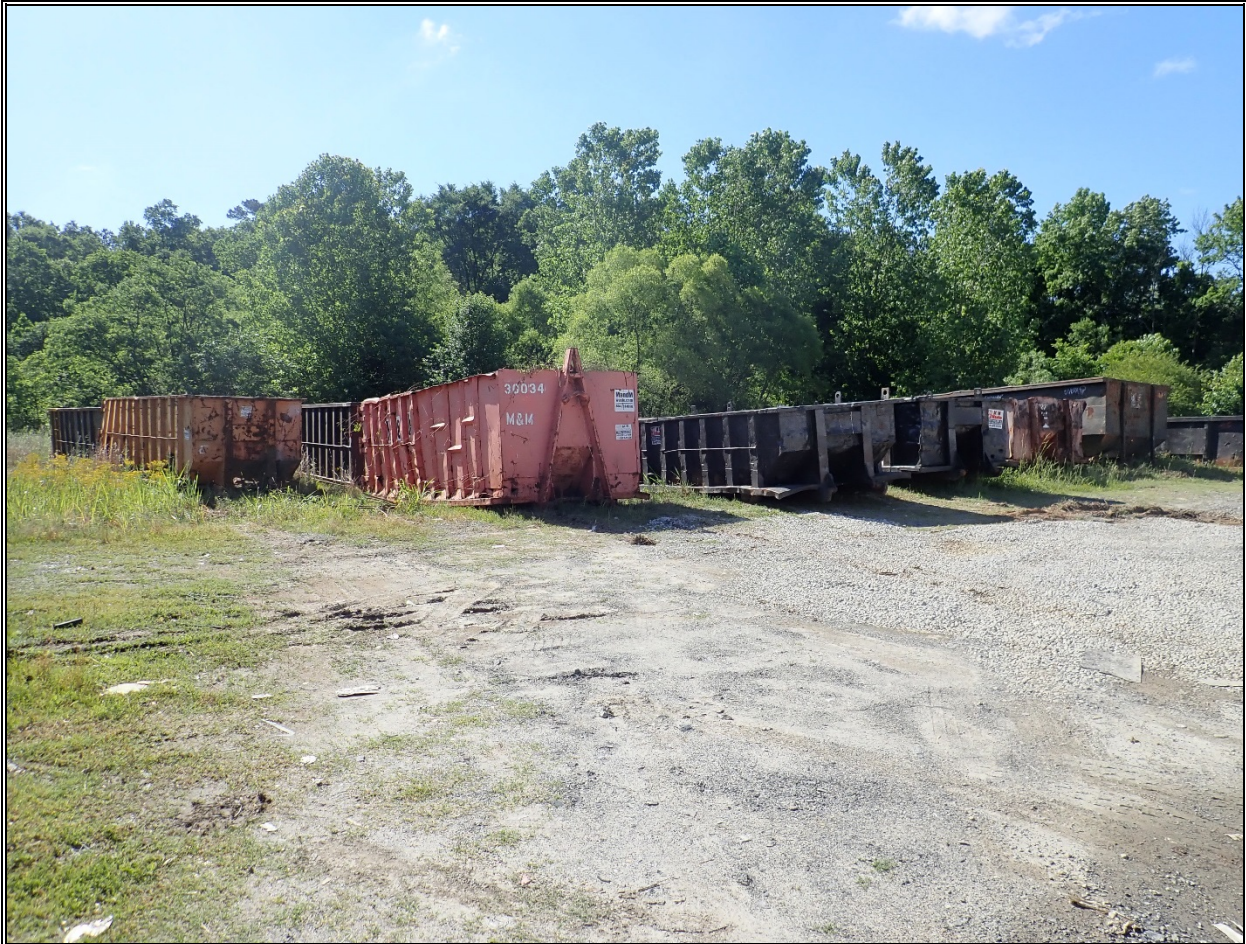
Roll-off boxes located to the southeast of the gravel parking area, approximately 75 feet south/southeast of Building A.

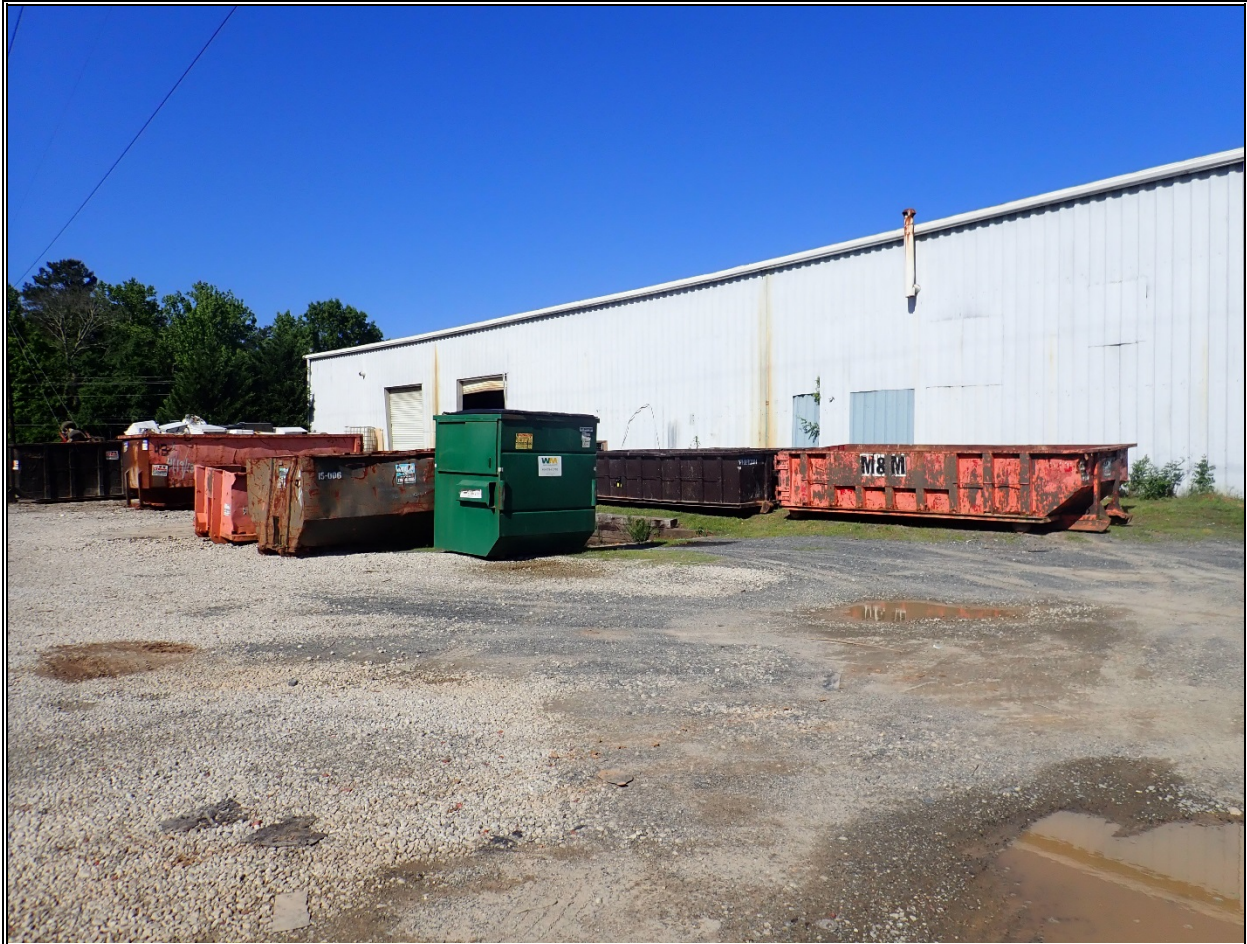
The point at which the ditch running along the northern boundary of the site discharges to the northwest side of the on-site pond.

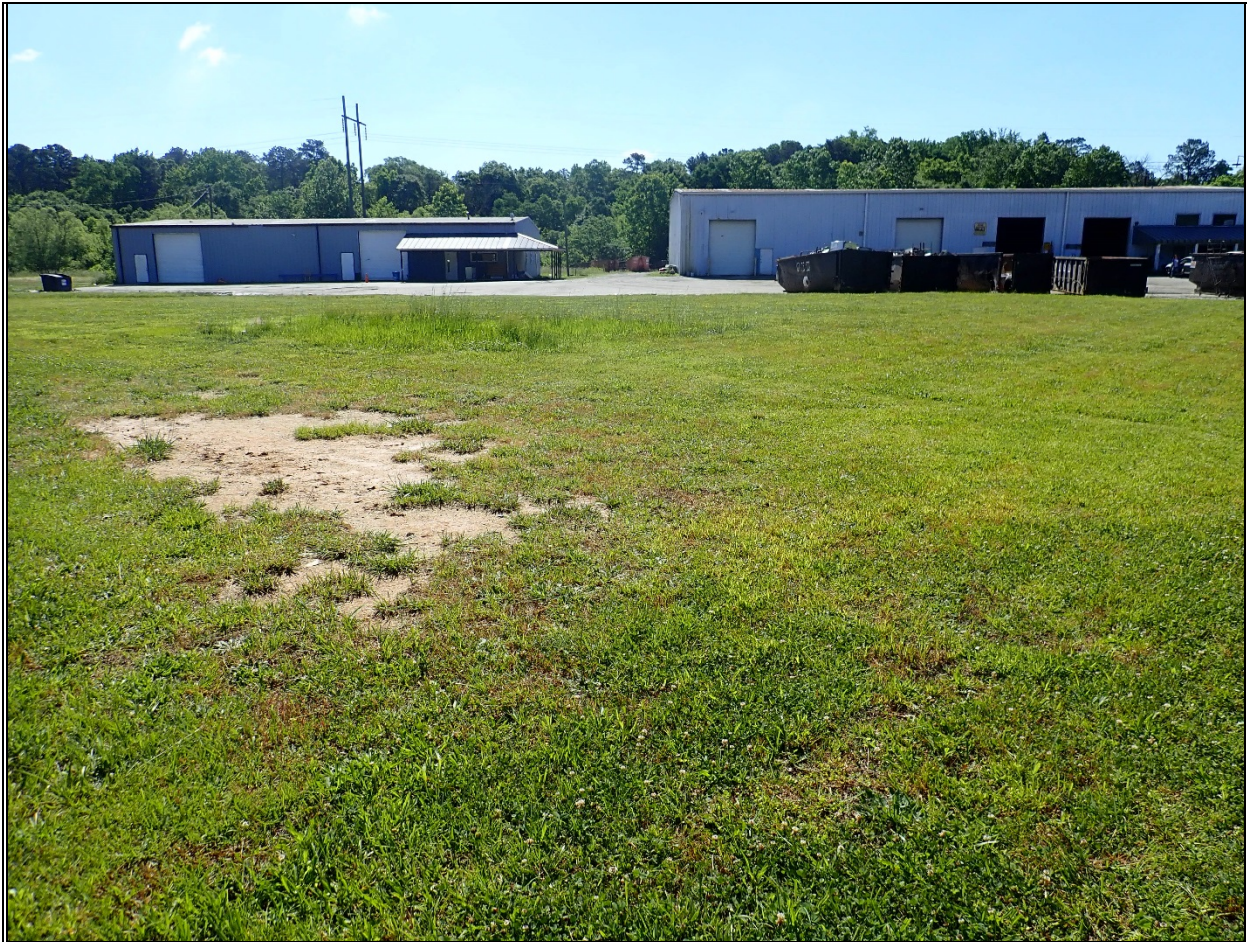
A small area barren of grass shown in the left central portion of the photograph. Building B and Building A are in the background of the photograph on the left and right, respectively.

- An area barren of grass and areas of stressed vegetation (approximately eight feet by 20 feet) were observed near the northwestern-most portion of the site, within the approximate area where USEPA removal activities were conducted in 2009 – 2010;

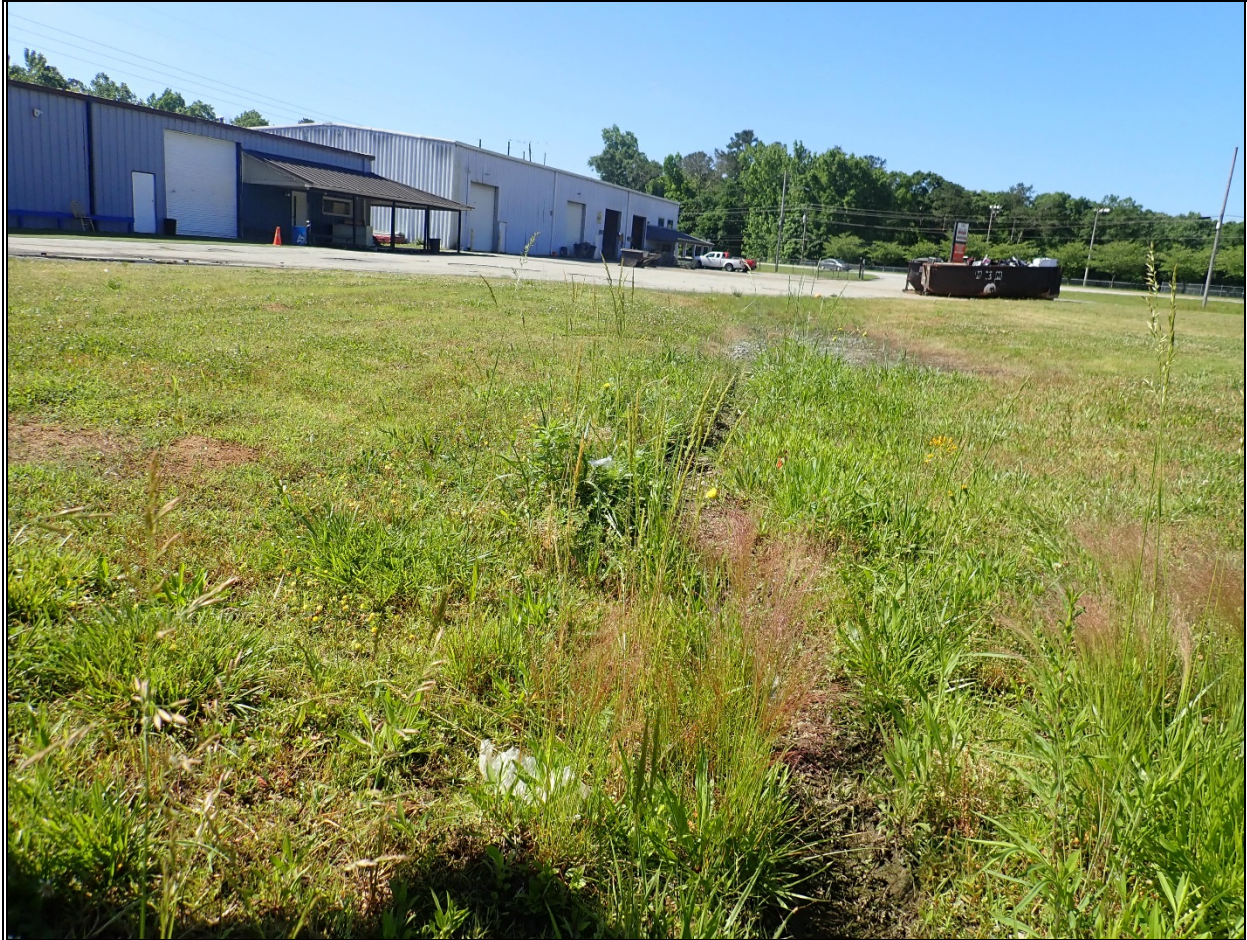
A small ditch extending from the northeastern-most portion of the paved on-site parking area towards the northeast is depicted from the central portion to the central foreground portion of the photograph.

- Well-defined drainage ditches were observed to the northwest of Building A, along the northwestern and northern boundaries of the site, just east of Austell Powder Springs Road. The ditch along the northwestern boundary slopes towards the north and intersects with the ditch along the northern boundary, which slopes towards the east/northeast and ultimately discharges to Pond A, located on the northeast portion of the site. A drainage ditch was observed extending from the northeastern-most paved area to the ditch running along the northern boundary of the site. No water was observed within the drainage ditches at the time of the site reconnaissance. Site-generated run-off from areas north and northwest of the metal buildings flows through the ditches and ultimately discharge to Pond A;

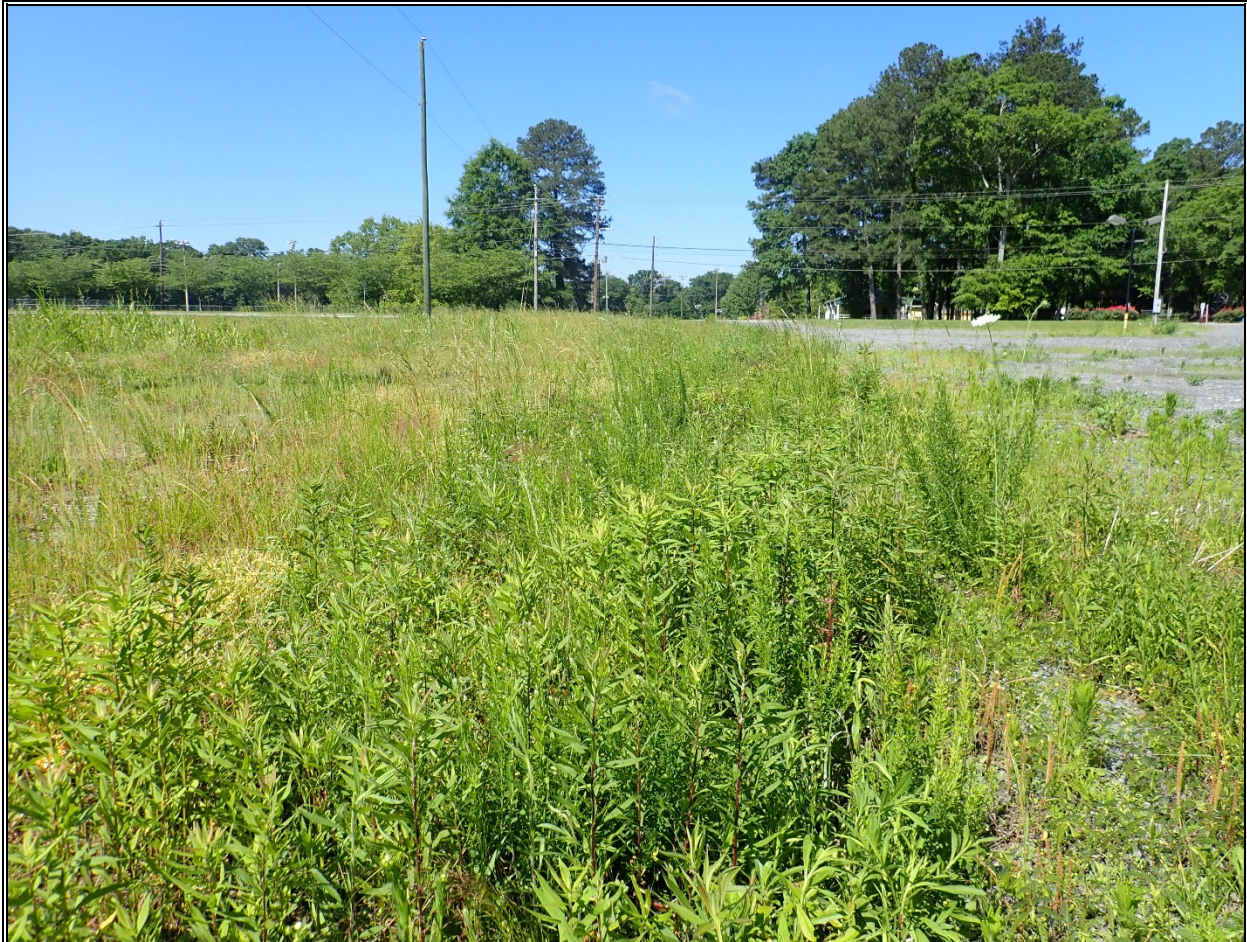
A ditch located along the northern boundary of the site running west to east is depicted near the central portion to the central foreground portion of the photograph.

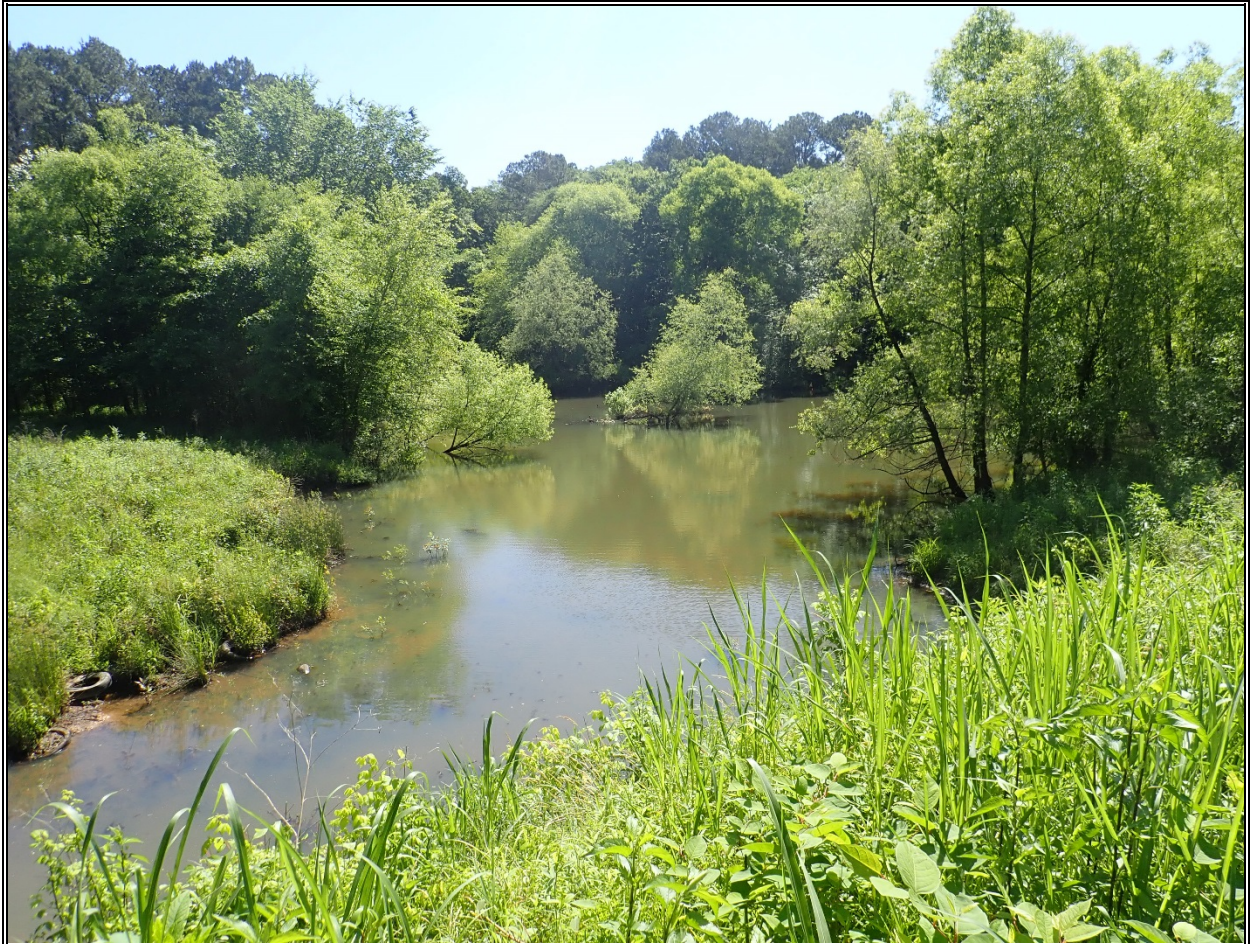
An area of depression and stagnant water located just north of Sweetwater Creek. Site generated run-off from the south and southwestern portion of the site flows through this drainage area within a series of ditches and depressions.

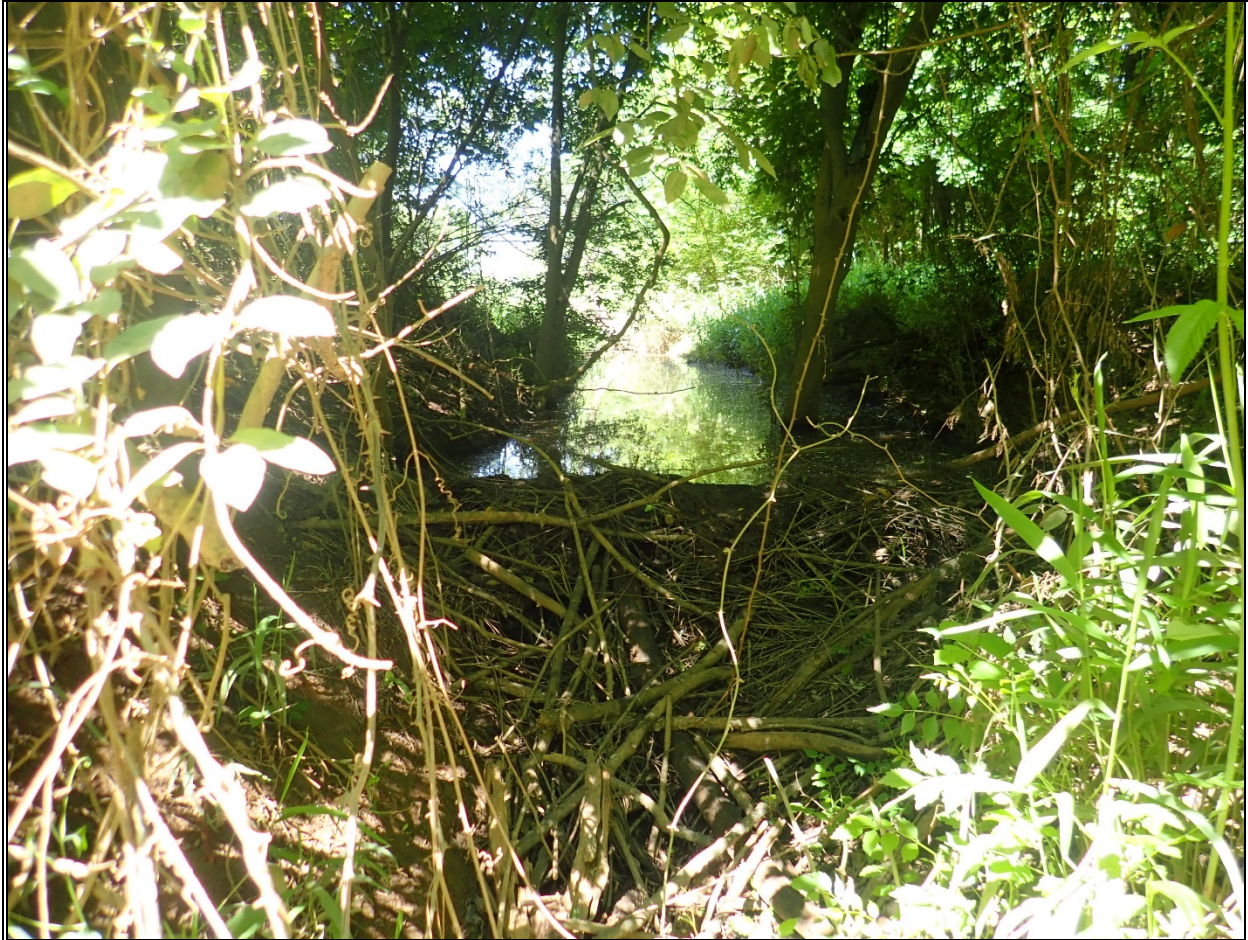
A dam comprised of sticks and logs located on the northeastern end of the on-site pond.

- Multiple turtles and geese were observed within Pond A. Tall grass, shrubs and trees circumscribed Pond A. An approximately 10-foot-long dam comprised of sticks and logs was observed on the northeastern end of Pond A. An approximately 25-foot-long well-defined drainage ditch was observed extending from the dam to Sweetwater Creek. No water was observed within the drainage ditch at the time of the site reconnaissance;

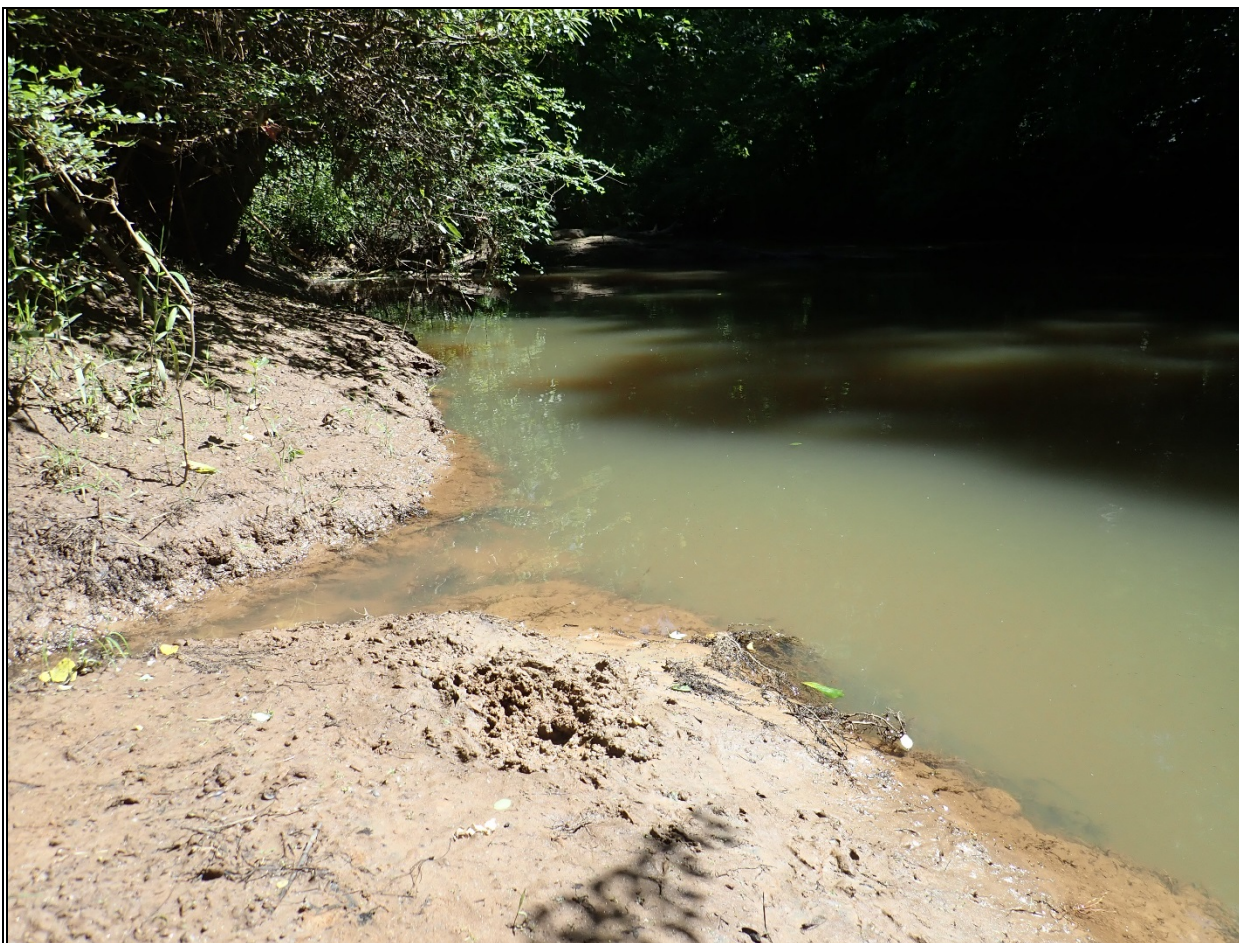
Depicted near the lower left to central portion of the photograph, the point at which a small ditch extending from the dam discharges to Sweetwater Creek.

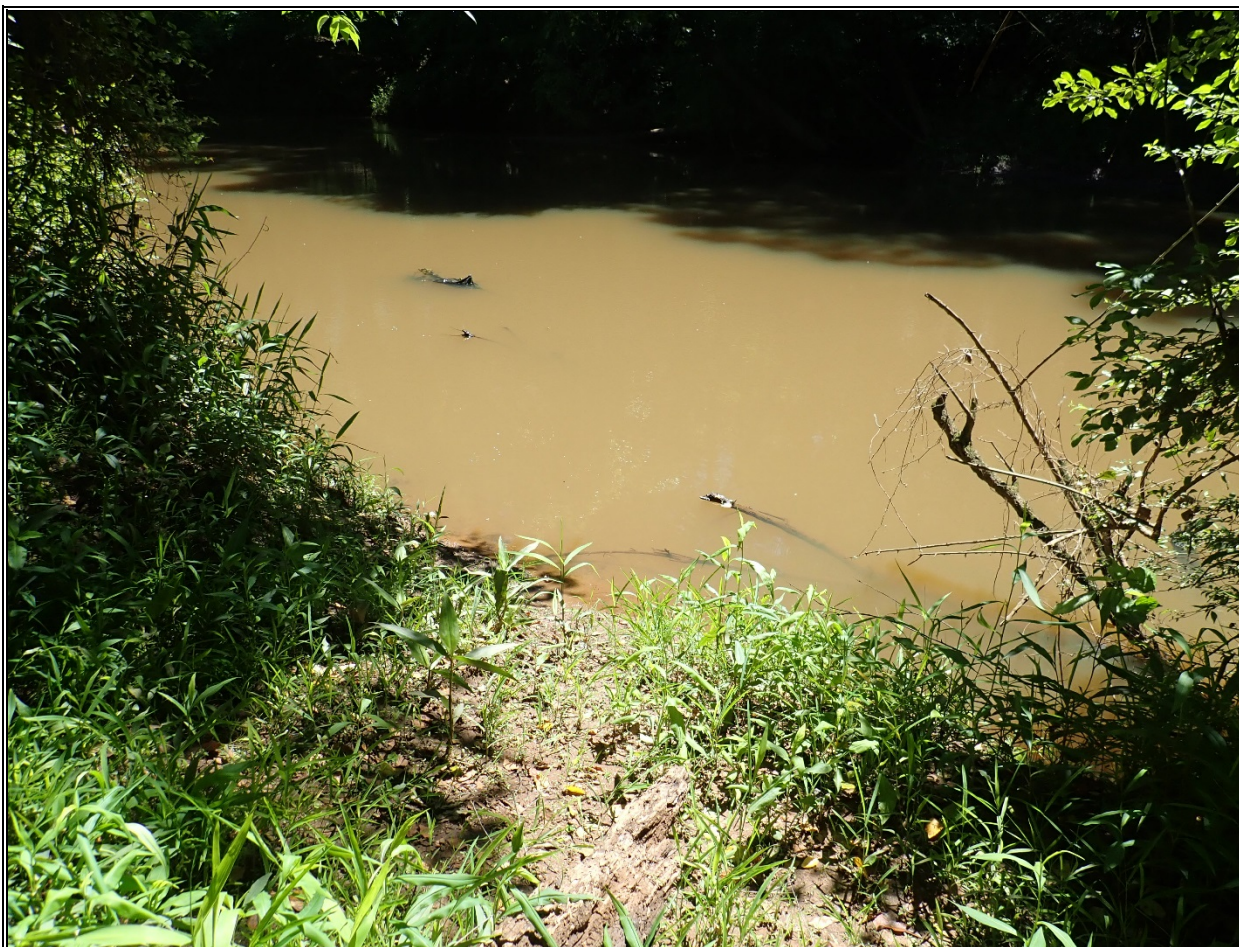
Depicted near the lower central portion of the photograph, the point at which site generated run-off from the south and southwestern portion of the site discharges to Sweetwater Creek.

- A well-defined drainage ditch was observed to the southwest of Building A along the western boundary of the site, just east of Austell Powder Springs Road. The ditch along the southwestern boundary slopes towards Sweetwater Creek to the south/southeast, meanders towards the northeast through low-lying areas paralleling Sweetwater Creek and ultimately discharges to Sweetwater Creek at a point approximately 300 feet north (downstream) of the Austell Powder Springs Road bridge over Sweetwater Creek; and
